# FEEG2005 Consultancy Report

## Abstract

In this document, I will analyse the failure mechanism of a piece of rebar that was used in a motorway. I will explain how the failure surface describes the loading conditions and what lead to the final failure. I will also make recommendations for how to avoid failure in the future.

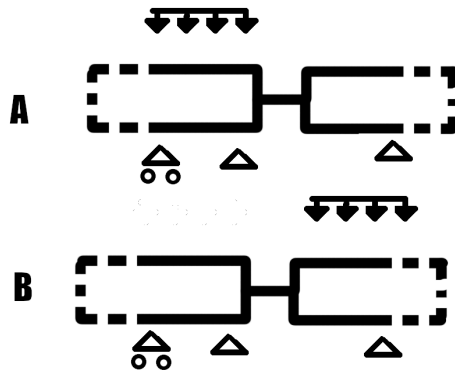
The raft that the rebar was in recently experienced subsistence, changing the loading conditions. This will have lead to reverse bending, as is visible in Figure 1. When a vehicle drives on the raft that was not affected by the subsistence, there will be a positive moment on the rebar. This leads to the bar bending downwards, as is shown in A. When the vehicle then moves onto the raft affected by subsistence, there will now be a negative moment on the rebar, as shown in B. In addition to this, the porosity of concrete means that when salt is used, corrosive fluids will be in contact with the rebar. This will lead to pitting and therefore stress concentrations as localised corrosion occurs. There will likely be electrochemical cells as some parts of the rebar will be surrounded by pores in the concrete but others will be surrounded by material. This will naturally lead to a difference in oxygen concentration and crevice corrosion.

Figure 1: Diagram of how the loading conditions changed when a vehicle drives over a concrete raft

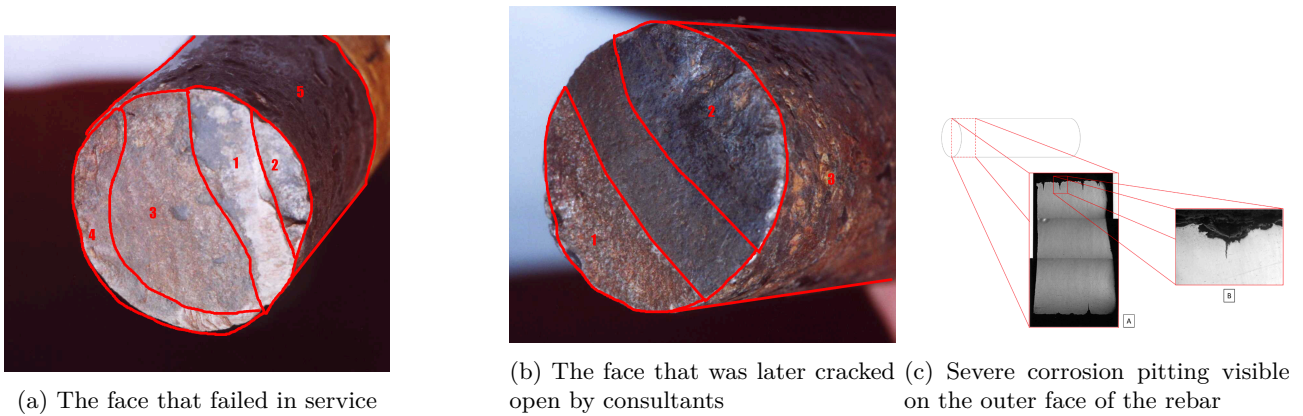
It is clear from Figure 2 that the rebar was undergoing reverse bending. This is because the final fracture regions are on opposite sides of the rebar, visible in  $a_{1,2}$  and  $b_1$ . There was also severe corrosion visible. This is evident through multiple methods, such as the large number of ratchet marks, labelled as  $a_4$  and  $b_1$ . These indicate where other cracks started to grow on other planes, and then intersected the main plane. Many of these are visible on both of the fracture faces, indicating the large number of other crack initiation sites. In addition to this, Figure 2c shows a look down one of the sides of the rebar. It is evident that there is corrosion pitting in many places. In addition to this, there appears to be crevice corrosion, leading to the long thin cracks near the tip. These have a small tip radius, leading to a large stress intensity factor and faster failure. The extent of this corrosion is clear from  $a_5$  and  $b_3$ , and the number of other corrosion pits makes it clear that the corrosion was a significant cause of the failure.

Figure 2: The faces of the samples of rebar

In Figure 2a, there is evidence of beech marks on  $a_3$ . These can be used to point back to the crack initiation sites, and indeed they point to the corrosion pits and ratchet marks in  $a_4$ .

When the subsistence occurred under the raft, this will have led to the loading conditions going from mostly unidirectional bending to reverse bending. Because of this, the stress ratio will go from being positive initially from the constant dead load of the structure and the live load of vehicles and weather on top, to negative from the live load being both compressive and tensile. It is unlikely that this was accounted for in the design phase.

The relatively large final fracture regions from sites  $a_{1,2}$  and  $b_1$  show that  $\sigma_{nom}$  was relatively low. The fairly flat nature of the final fracture region indicates that there was no significant stress concentration. This suggests that the main role played by corrosion was initiating the crack, and after there was a crack there were no other significant effects played. This also indicates that the cross section of the rebar did not cause accelerated failure, and this makes sense because there are no tight radii or keyways visible.  $a_1$  shows shear lips indicating that this was a ductile failure. Because the shear lips are always  $45^\circ$  to the maximum opening stress, it is fairly clear from the angle that the forces were not only tensile, further strengthening the argument for reverse bending.

To minimise the risk of failure reoccurring, a number of methods could be employed. The first method in response to fatigue failure is to try to reduce the fatigue the structural member is experiencing. However due to the nature of motorways, this is not feasible. This would either require removing the rebar from the concrete, which would severely hamper the concrete's ability to perform, or reduce the magnitude of stress fluctuations. Reducing the magnitude of stress fluctuations would most likely mean reducing the maximum weight of vehicles travelling on the motorway, which is only achievable after policy changes from Westminster. These all alter  $\sigma_m$  in Equation 1.

As corrosion was also an issue, there are a number of methods to tackle this. For example, austenitic or duplex stainless steels could be used instead of mild steel that is typically used in rebar [2]. This will obviously lead to higher costs though, as mild steel is typically cheaper than stainless steels [3]. On the other hand, there is more control over the localised corrosion rate based on the alloy composition [3]. In addition to corrosion resistance,  $\sigma_{a0}$  and  $\sigma_{ts}$  would likely change.

Another method is shot or laser peening. These put compressive stress at the top of the material so that it is harder for cracks to grow. Shot peening is cheaper, but does result in less protection, as laser peening means that the stresses reach further below the surface of the material. Carburisation could also be used, but as this is a time and temperature dependant process, this would be extremely costly. The surface would be harder, meaning that it would be harder for cracks initiate. This will not affect anything in Equation 1, however it will increase the amount of time spend in Regime A of the Paris Law.

The best, most effective method is to reduce stress on each piece of rebar. Mean stress can drastically affect the mean number of cycles to final failure, so reducing this will prolong the life of existing rebar. There is already a large supply chain for existing rebar, meaning that costs will likely be reliable, and it does not add any additional complexities that may not be considered in the design phase. If the design stress is lower,  $\sigma_m$  is reduced, possibly by a large amount, and the lifespan will increase accordingly. In addition to this, regular inspections would help in the future. If the subsistence can be identified before it causes major problems, the lifespan of the rafts will be dramatically improved. The frequency of these inspections does need to be balanced against the cost of inspecting every mile of motorway, however.
